**Sample
Report**

Inspection Report

Property Address:
2980 Oakstone Creek Pl
San Diego, CA

InSight Home Inspections of San Diego

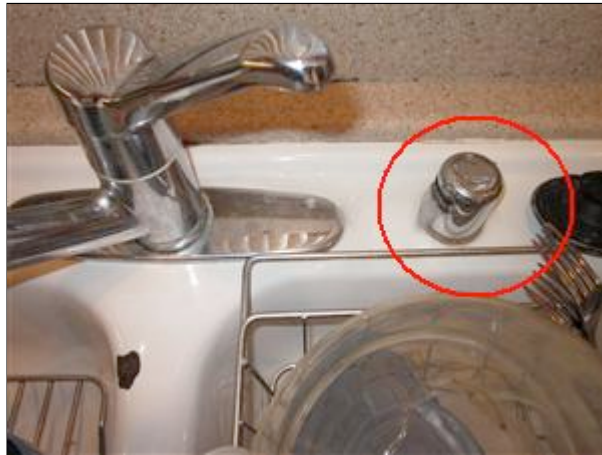
1.0 Picture 1

The dishwasher air gap was overflowing at the time of the inspection. This indicates an obstruction or kink in the drain hose. Recommend corrections by a licensed plumber.

The dishwasher air gap was overflowing at the time of the inspection. This indicates an obstruction or kink in the drain hose. Recommend corrections by a licensed plumber.

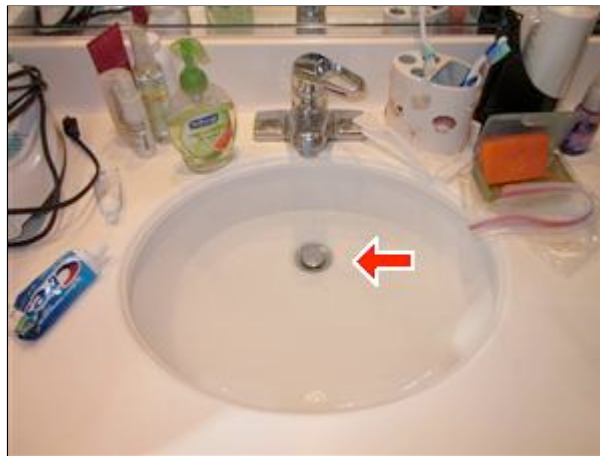
2.0 Picture 1 left sink

Slow drain noted at the upper left hallway bathroom sink. Recommend professional clean out or necessary corrections.

Slow drain noted at the upper left hallway bathroom sink. Recommend professional clean out or necessary corrections.

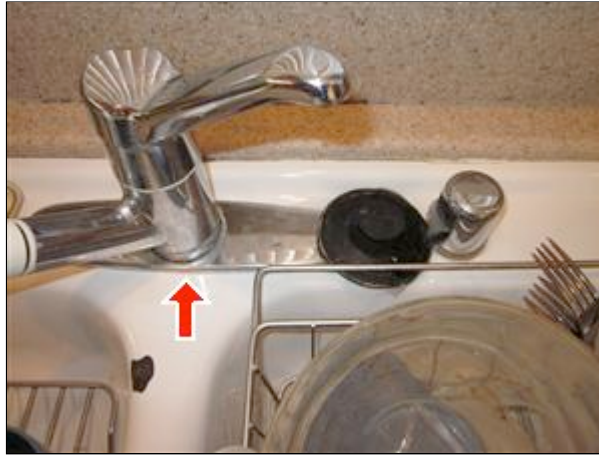
2.2 Picture 1

(1) The kitchen faucet is loose on the counter. Recommend repair.

- (1) The kitchen faucet is loose on the counter. Recommend repair.
- (2) The rear outdoor faucet was inoperable. Advise inquiry with the seller and corrections as necessary.
- (3) The master bathroom toilet "runs". This usually indicates worn tank hardware. Recommend necessary corrections.
- (4) The hallway tub diverter sprays water from the shower head and tub spout simultaneously. This usually indicates a worn spout (diverter). The spout is corroded. We recommend necessary corrections by a licensed plumber.
- (5) The upper hallway shower valve drips at the handle. Recommend repair by a licensed plumber.

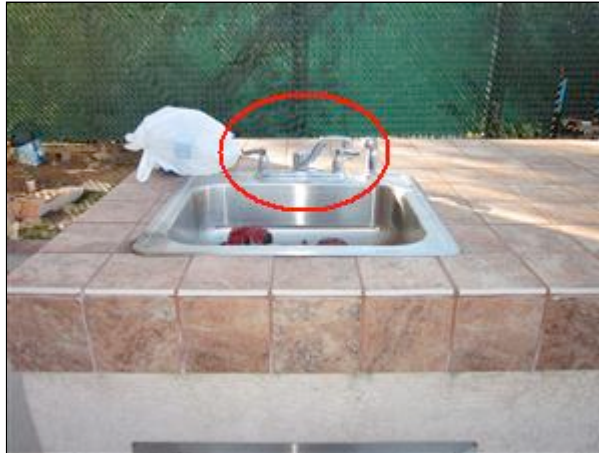
2.2 Picture 2

(2) The rear outdoor faucet was inoperable. Advise inquiry with the seller and corrections as necessary.

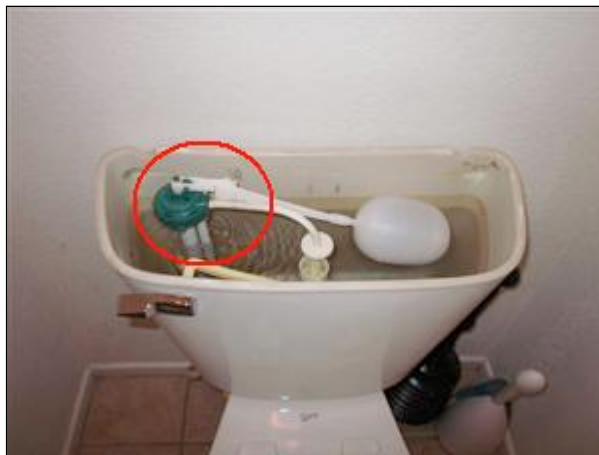
2.2 Picture 3

(3) The master bathroom toilet "runs". This usually indicates worn tank hardware. Recommend necessary corrections.

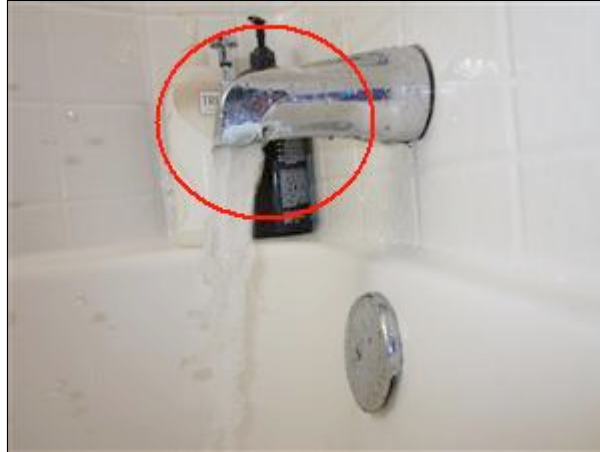
2.2 Picture 4 spout/diverter

(4) The hallway tub diverter sprays water from the shower head and tub spout simultaneously. This usually indicates a worn spout (diverter). The spout is corroded. We recommend necessary corrections by a licensed plumber.

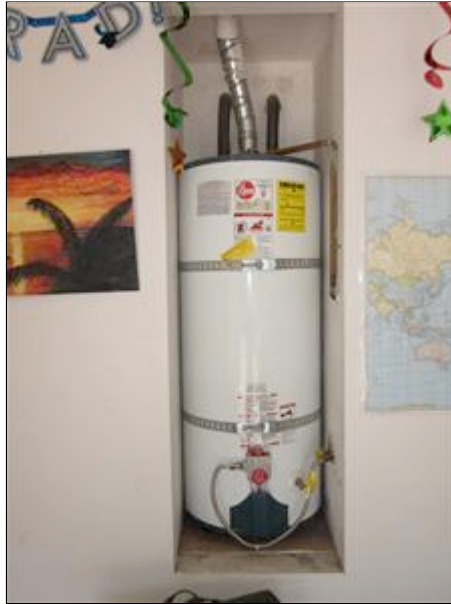
2.3 Picture 1

Picture of water heater.

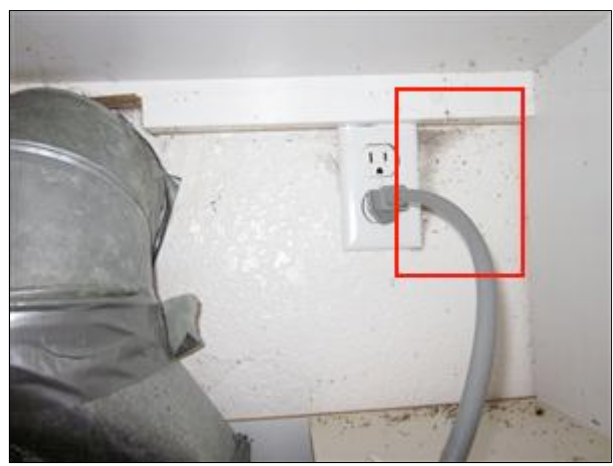
3.1 Picture 1 view above microwave

Wall Material: Gypsum Board
Comments:
 Discoloration noted above the microwave cabinet; dry at the time of the inspection. Recommend professional cleaning and sanitation.

Discoloration noted above the microwave cabinet; dry at the time of the inspection. Recommend professional cleaning and sanitation.

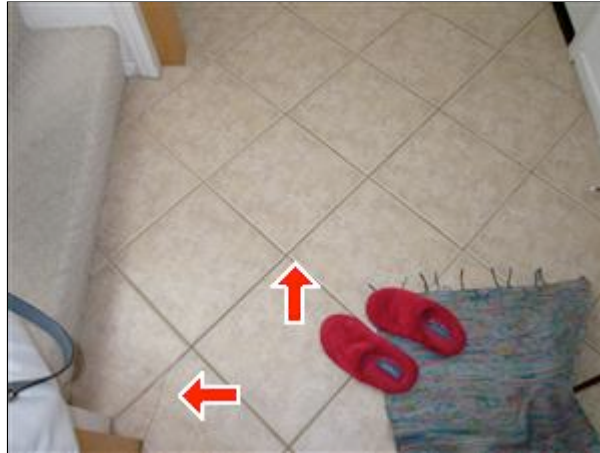
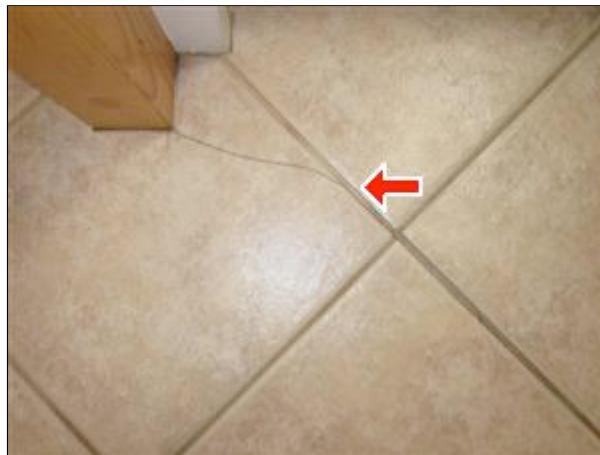
3.2 Picture 2 cracked tile

Cracked tile and grout noted in the entry up to 1/16". This appears to a shrinkage or curing crack.

Cracked tile and grout noted in the entry up to 1/16". This appears to a shrinkage or curing crack.

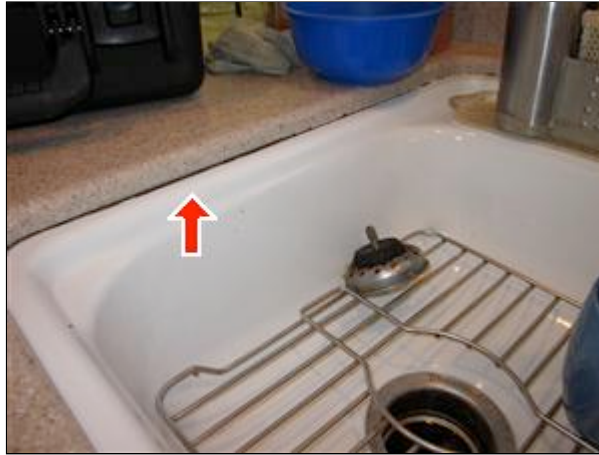
3.4 Picture 1 kitchen sink

(2) Stains noted around the kitchen sink (sealant). Recommend restoration.

(2) Stains noted around the kitchen sink (sealant). Recommend restoration.

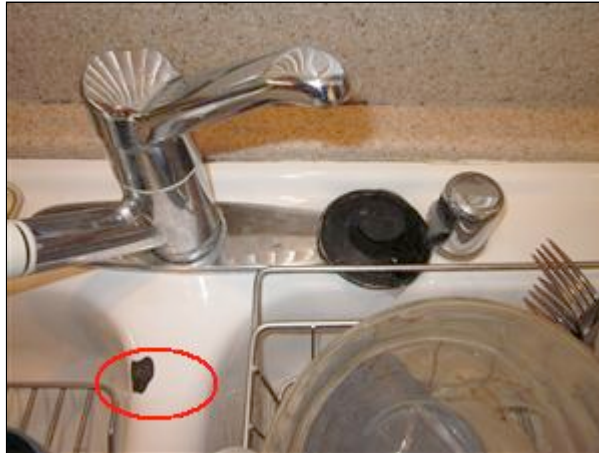
3.4 Picture 2

(3) Chip noted at the kitchen sink.

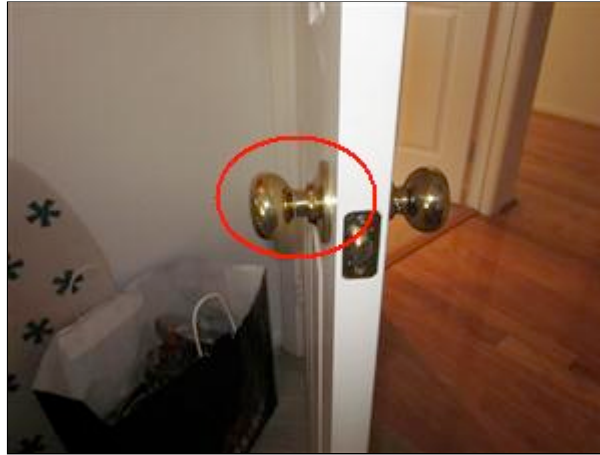
3.5 Picture 1

The 3rd bedroom (upstairs) door handle is damaged/loose. Recommend adjustment or replacement.

The 3rd bedroom (upstairs) door handle is damaged/loose. Recommend adjustment or replacement.

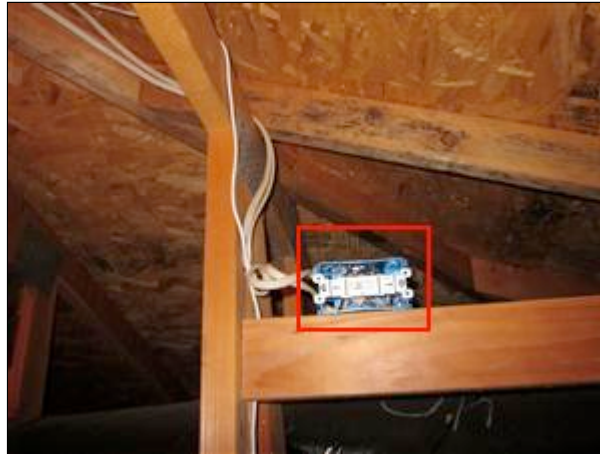
4.5 Picture 1 attic view

The switch cover is missing in the attic. Advise installing for safety.

The switch cover is missing in the attic. Advise installing for safety.

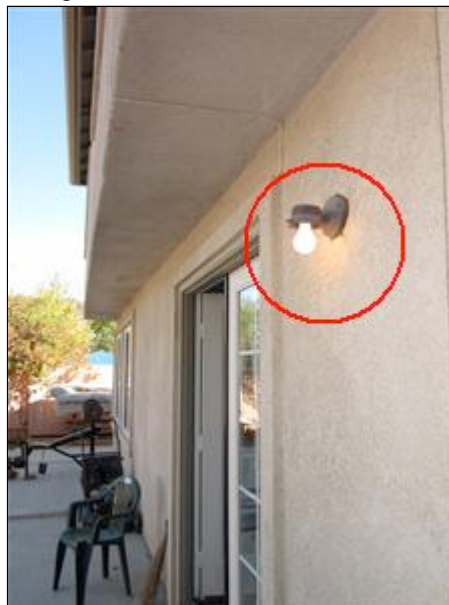
4.6 Picture 1 rear

(2) The rear patio light cover is missing.

(2) The rear patio light cover is missing.

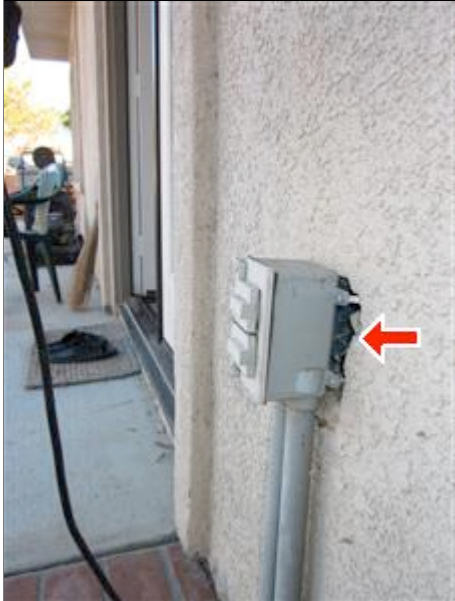
5.1 Picture 1 rear patio

5.1 WALL CLADDING FLASHING AND TRIM
Siding Material: Stucco
Comments:
 Hole damage noted at the rear patio stucco near the outlet. Recommend repair to prevent moisture/pest intrusion.

Hole damage noted at the rear patio stucco near the outlet. Recommend repair to prevent moisture/pest intrusion.

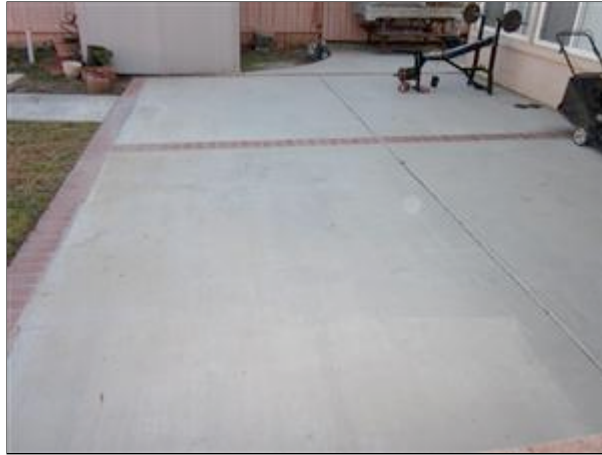
5.2 Picture 1 rear patio

Common cracks noted at the rear patio.

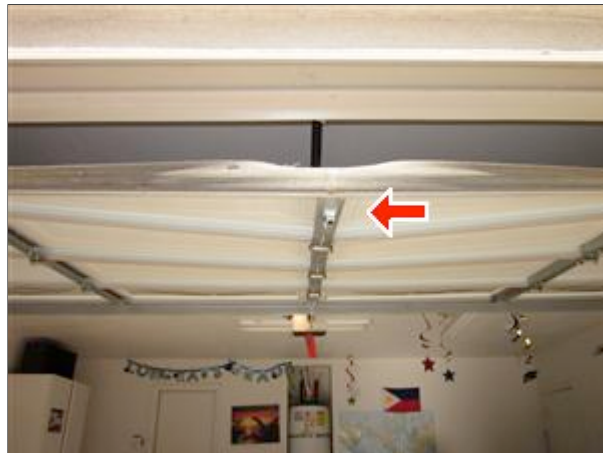
6.5 Picture 1

The garage vehicle door is dented/damaged. Advise replacement by a qualified door company.

Unable to test the safety reverse due to damaged vehicle door. Refer to 6.5.

The garage vehicle door is dented/damaged. Advise replacement by a qualified door company.

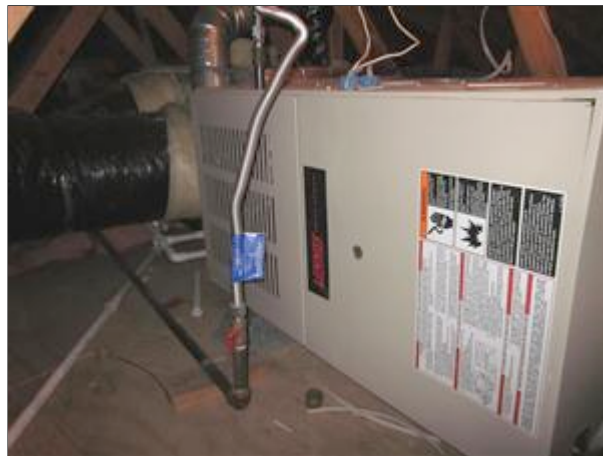
7.0 Picture 1 attic view

Heat Type: Forced Air
Energy Source: Gas
Number of Heat Systems (excluding wood): One
Heat System Brand: LENNOX
Approximate Age of Furnace: appears original
Comments:
 Picture of furnace (s)

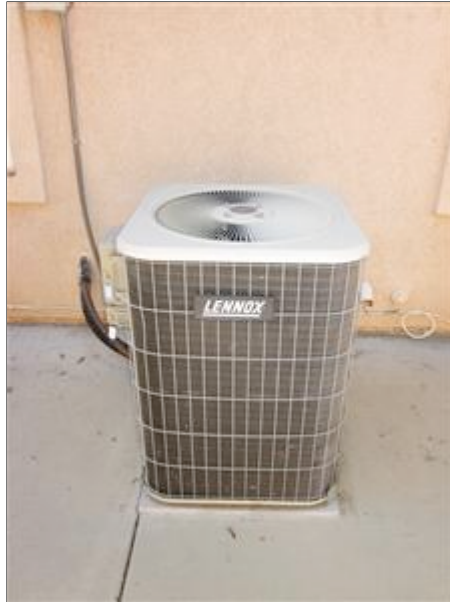
7.4 Picture 1

Comments:
 The A/C was tested and found to be cooling at a normal range of between 14 and 20 degrees at the air registers. This appears to be the original. We recommend regular maintenance.

Number of AC Units: One
Cooling Equipment Type: Air Conditioner Unit
Cooling Equipment Energy Source: Electricity
Central Air Manufacturer: LENNOX
Comments:
Picture of A/C compressor.
